Appendix O

Photos

Swim Areas

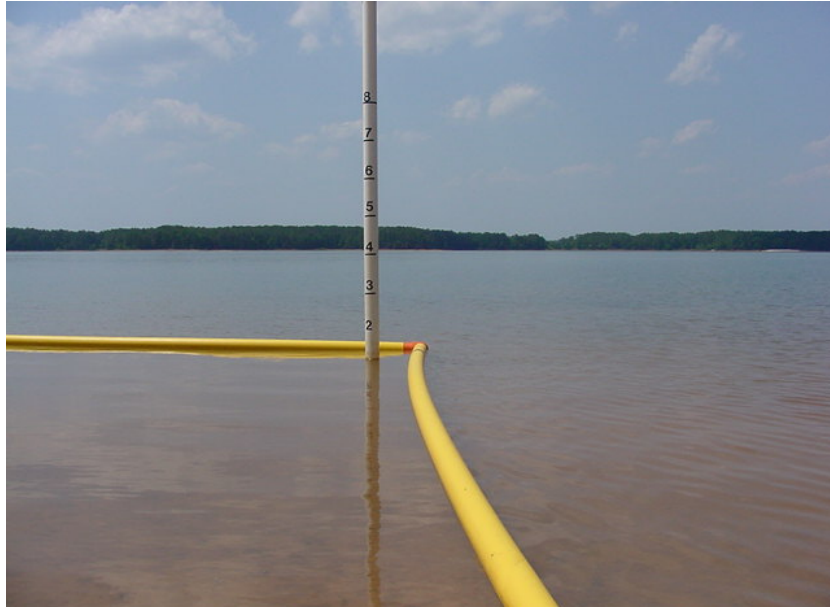
Photo O-1. Beach delineation and depth marker. J. Strom Thurmond Lake. The required swim area limit delineation is accomplished using floating pipeline. Note the required depth marker delineating each 1-ft change in water depth (Table 5.11)

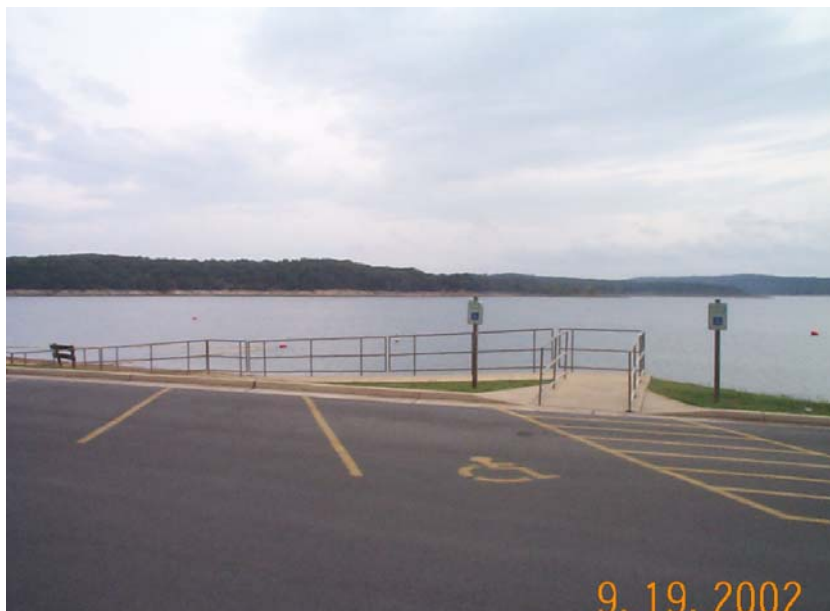
Photo O-2. UA ramp to swimming area. Cranfield Park, Norfork Lake, AR. A concrete ramp from the parking lot to the swimming area enables wheelchair users to access the water (Para. 5.2.1)
